Your Inspection Report

1234 School House Road
Yourtown, US 12345

Prepared for: Bob Smith

Prepared by: Haworth Residential Inspections, LLC
9600 Colerain Ave., Suite 110
Cincinnati, OH 45251

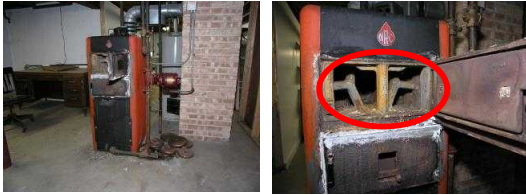
13. Basement Heating System Heating System Operation: Recommend replacement Boiler system is antiquated and lacks safety features found on newer units including non-sealing combustion chamber which can cause health issues

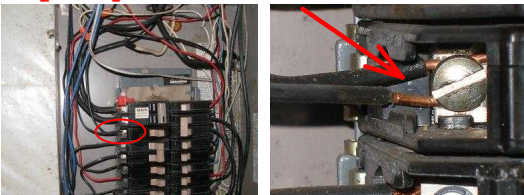
10. Basement Electric Panel Breakers: Copper Double taps are present at breakers. These circuits need to be moved to their own circuit breaker and cannot share a breaker. It is recommended that a qualified electrician inspect the new circuits and properly connect the new circuits to an individual breaker for each circuit

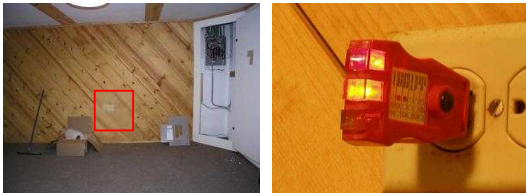
17. Main Basement Electrical: 110 VAC **Reversed polarity exists at several basement outlets**

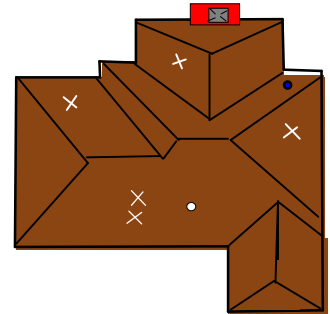
2. Roof Diagram

4. Material: Fiberglass shingle Nail popping through shingle surface in various locations causing potential water intrusion (see diagram above marked "x")

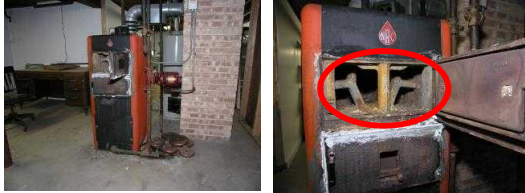
1. Heating System Operation: Recommend replacement Boiler system is antiquated and lacks safety features found on newer units including non-sealing combustion chamber which can cause health issues

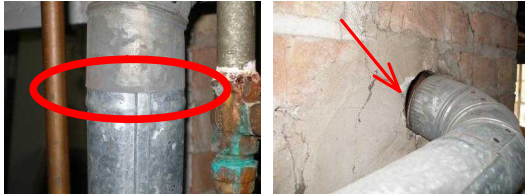
13. Flue Pipe: Single wall **Install screws at exhaust vent piping fittings, loose piping at chimney**

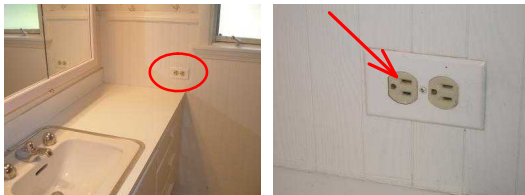
1. Closet: Single small
2. Ceiling: Plaster
3. Walls: Plaster, Ceramic Tile
4. Floor: Ceramic tile
5. Doors: Hollow wood
6. Windows: Wood casement
7. Electrical: 110 VAC **Non-GFCI circuit, Reversed polarity present**
